CONNECTICUT RIVER BASIN
WHATELY, MASSACHUSETTS

SOUTH DEERFIELD
MA 00522

PHASE I INSPECTION REPORT
NATIONAL DAM INSPECTION PROGRAM

JUNE 1979

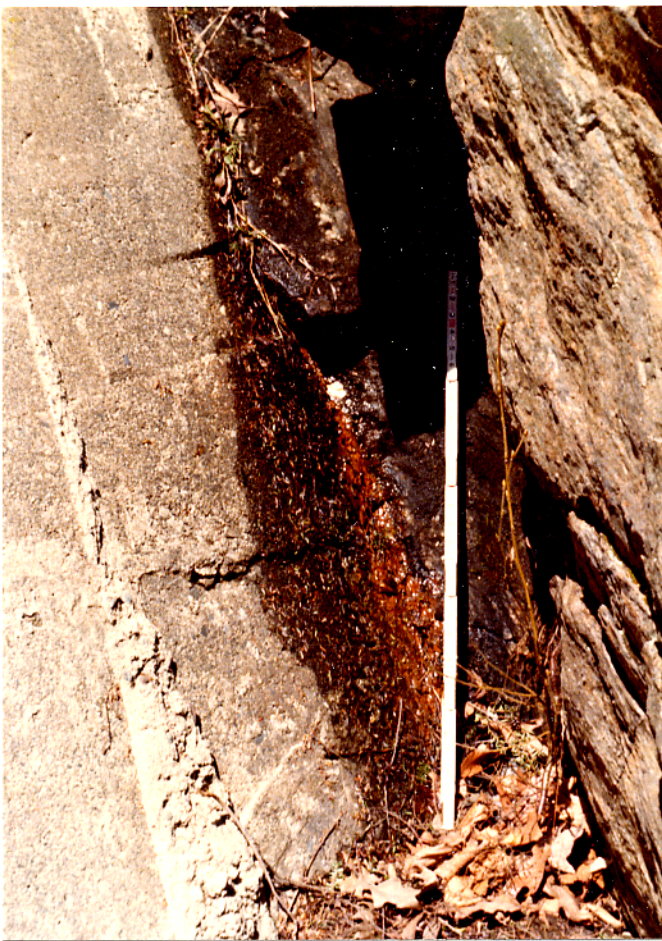
Photo 3 shows the contact between the left abutment and downstream face. Seepage was observed from this contact about 10 feet below the top of the dam (about elevation 414 feet). A close-up view of the seepage is shown in photo 1. Slight seepage was noted in an April 26, 1977 inspection report where the "concrete wall joins ledge base and ledge abutments of dam."

PHOTO NO. 1 - Seepage
through contact of concrete
dam and rock (schist) of
left abutment approximately
ten feet down from top of
dam.

2. The owner should establish a periodic procedure for frequently monitoring seepage from the joints of the right abutment and from the contact between the downstream face and left abutment. Also the owner should monitor vertical cracks and joints in the downstream face to determine if seepage occurs in the future.

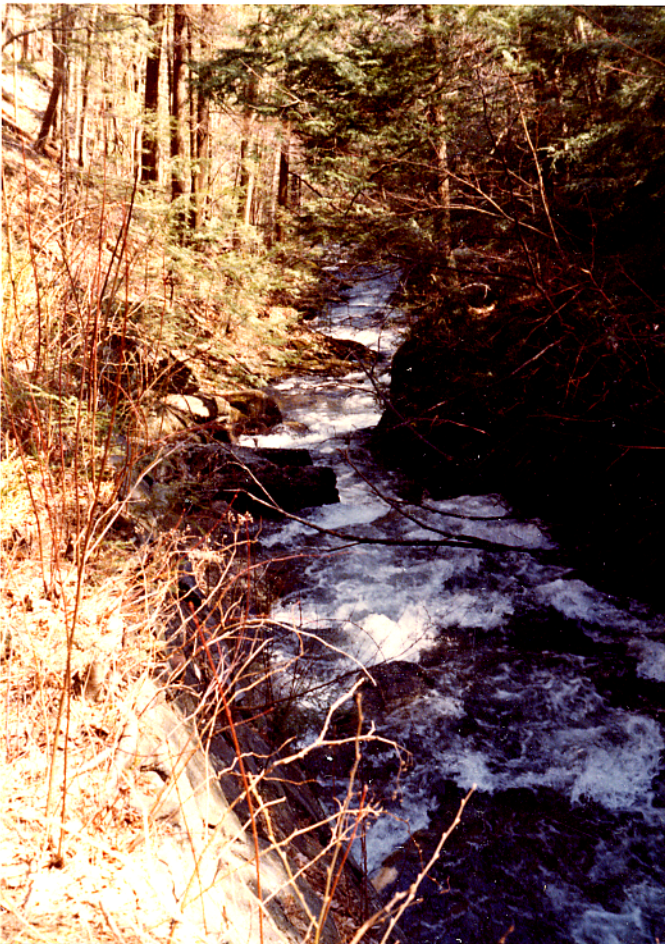
PHOTO NO. 2 - Downstream
channel as viewed from dam.

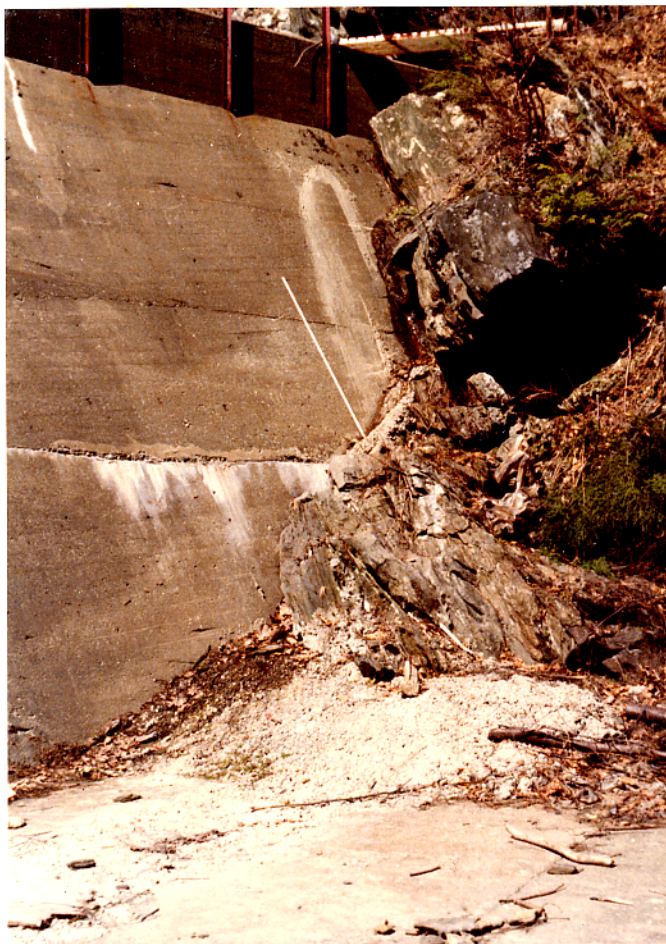
PHOTO NO. 3 - Contact
between dam and left
abutment.

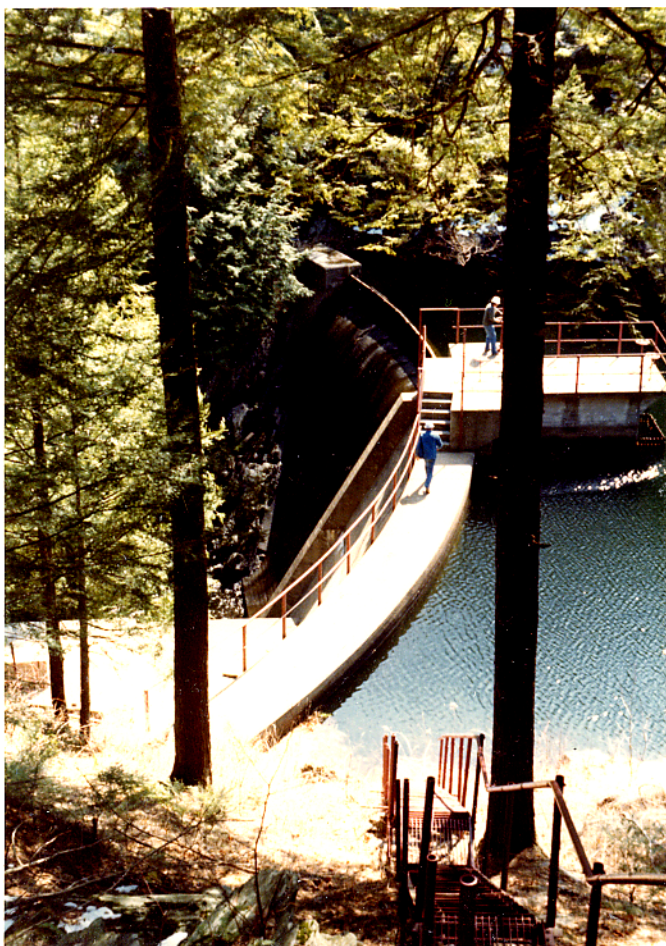
The upstream face was almost entirely under water at the time of the inspection, photo 4. According to sketches of the dam in past inspection reports, the upstream faces of the spillway and non-overflow section are both sloped at 3/4H:12V. The vertical crack in the downstream face of the non-overflow section (described in the Downstream Face) continues across the crest and down into the upstream pool. The upstream face of the main spillway could not be observed through the water surface.

PHOTO NO. 4 - Overall v
of crest from left abut

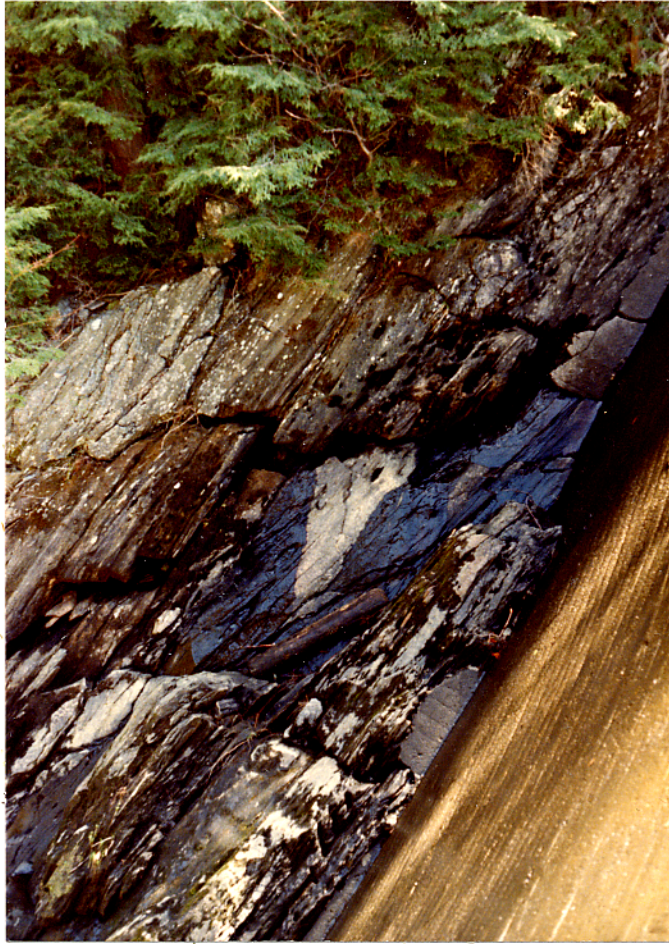
A small amount of seepage was observed through joints in the rock forming the spillway right abutment, as shown in photo 5. Close-up views of the seepage in this area are shown in photos 6 and 7. Seepage through joints in the rock of the right abutment was noted in an April 26, 1977 inspection report.

PHOTO NO. 5 - Seepage through joints in rock forming right abutment, downstream of spillway.

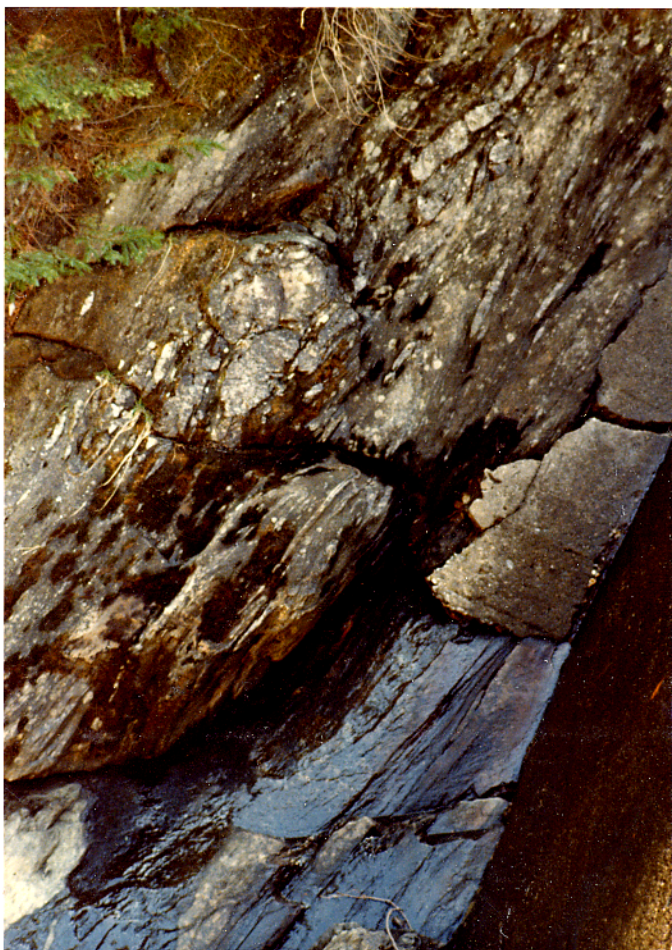
PHOTO NO. 6 - Close-up
view of seepage shown
in PHOTO NO. 5

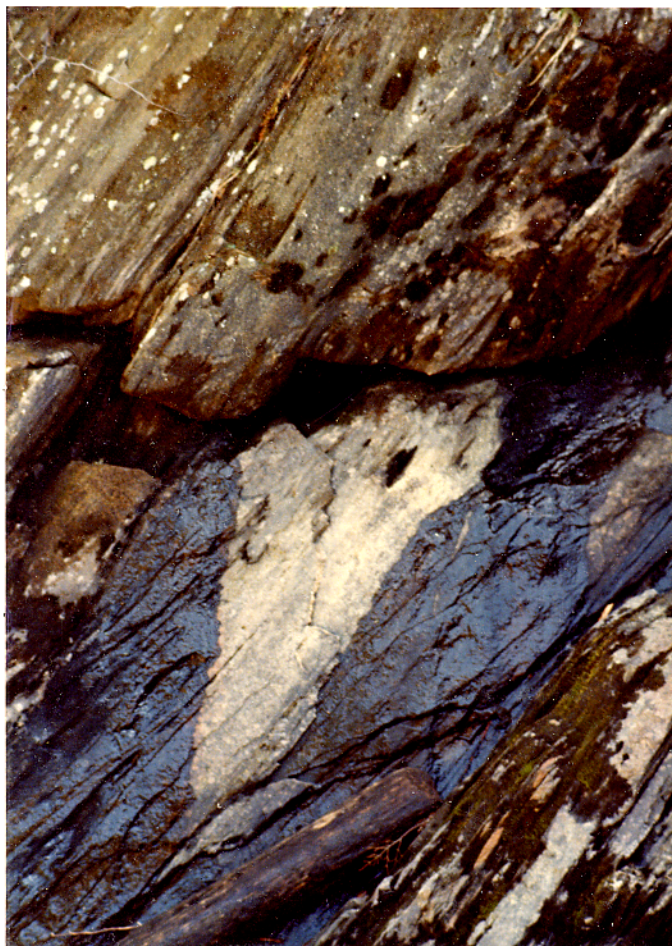
PHOTO NO. 7 - Close-up
view of seepage shown
in PHOTO NO. 5

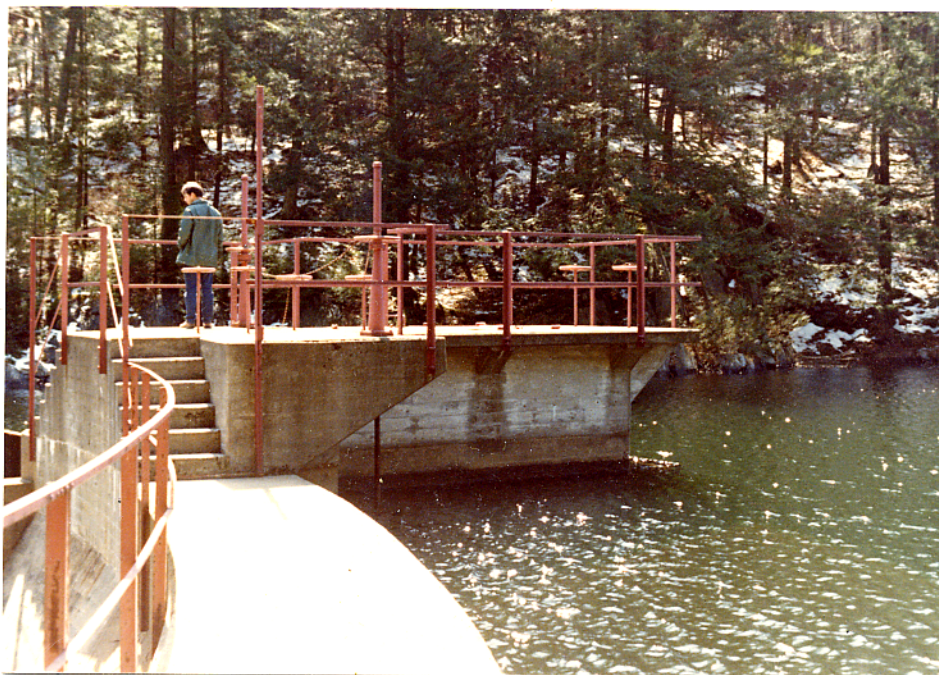
The general condition of the intake structure which could be observed above the water line, was good. The caretaker operates all gates regularly and they appear to be in working order.

PHOTO NO. 8 - Intake structure and controls viewed from left abutment.

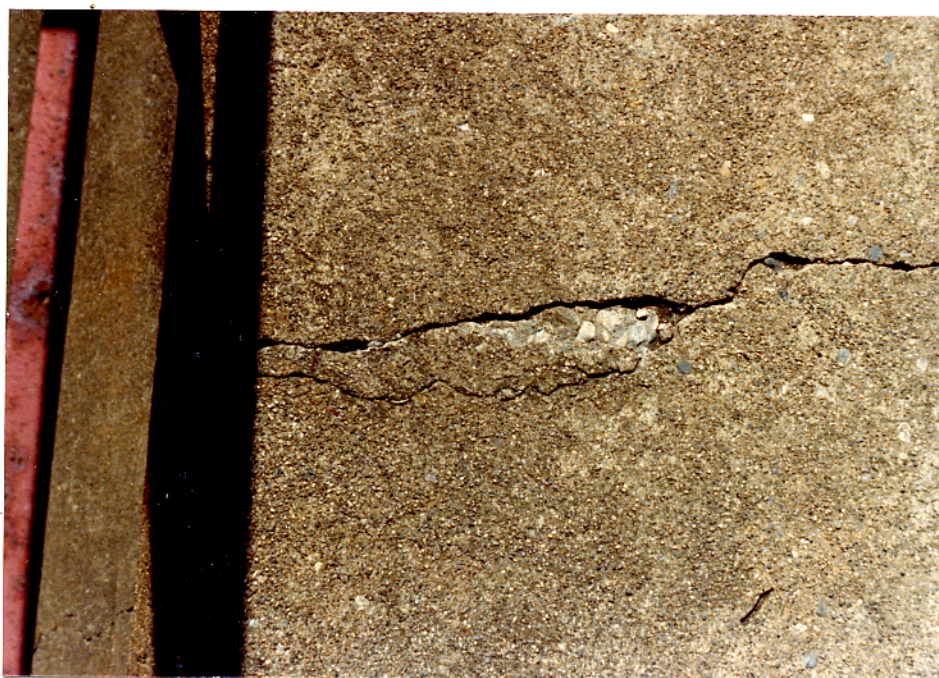
The crest of the non-overflow section is about 5 feet wide. The crack described within the Downstream Face of this section extends across the crest, photo 9. No seepage from this crack was observed at the crest. Elsewhere along this section, the crest appeared to be in good condition with no spalling or misalignment.

The downstream face of the concrete non-overflow section was observed to have a vertical crack extending from the toe to the top of dam, across the crest and down into the upstream pool, as shown by photos 9, 11 and 14. Minor seepage from this crack was occurring at approximately 7± feet up from the toe. An inspection report dated March 19, 1975 noted seepage through a vertical line crack which "extends from downstream toe of wall up to the top of wall, across the top and down the upstream face." The seepage was reported to be 10 feet to 12 feet from the toe. In an April 26, 1977 inspection report, no sign of seepage through the above vertical crack was noted. However, this latter report indicated minor seepage from a different vertical crack about 15 feet northerly of the spillway.

PHOTO NO. 9 - Crack in non-overflow section extending through top of crest..

1. Cracks in the concrete face should be repaired before they become enlarged.

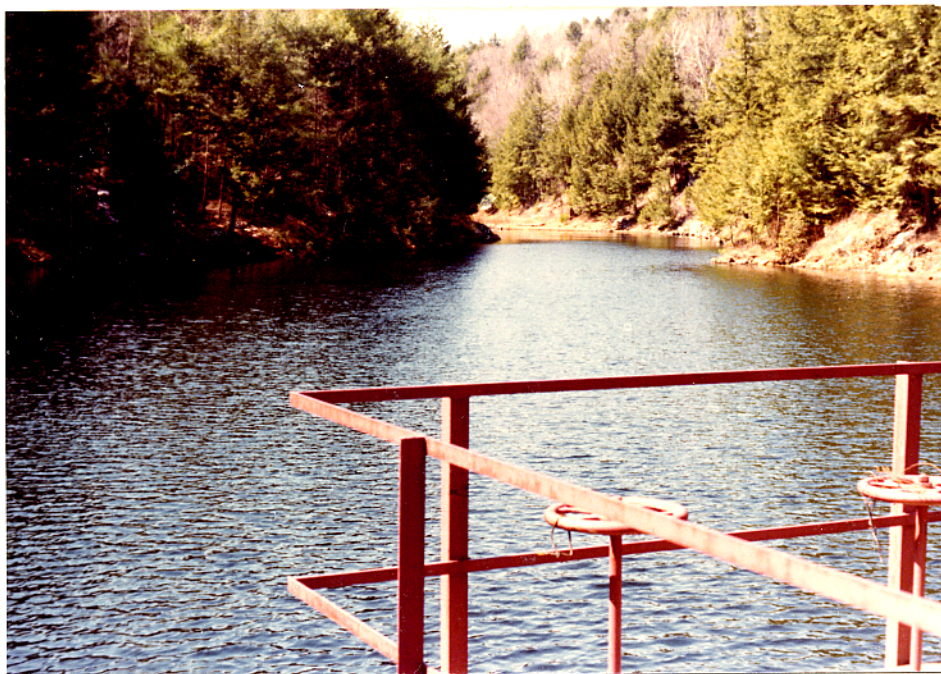
PHOTO NO. 10 - Upstream reservoir viewed from intake structure.

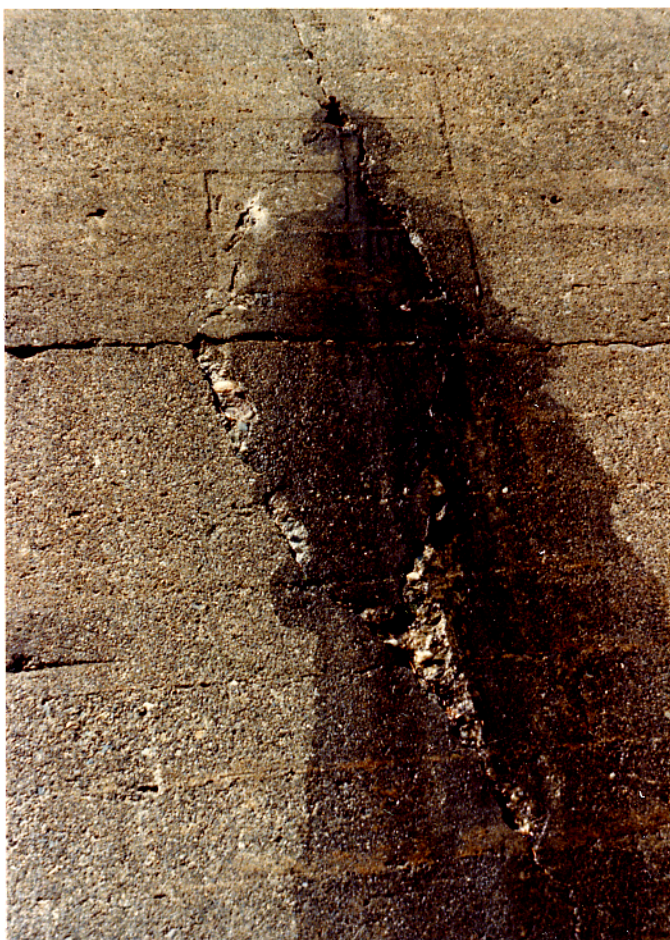
PHOTO NO. 11 - Close-up view of vertical crack in non-overflow section.

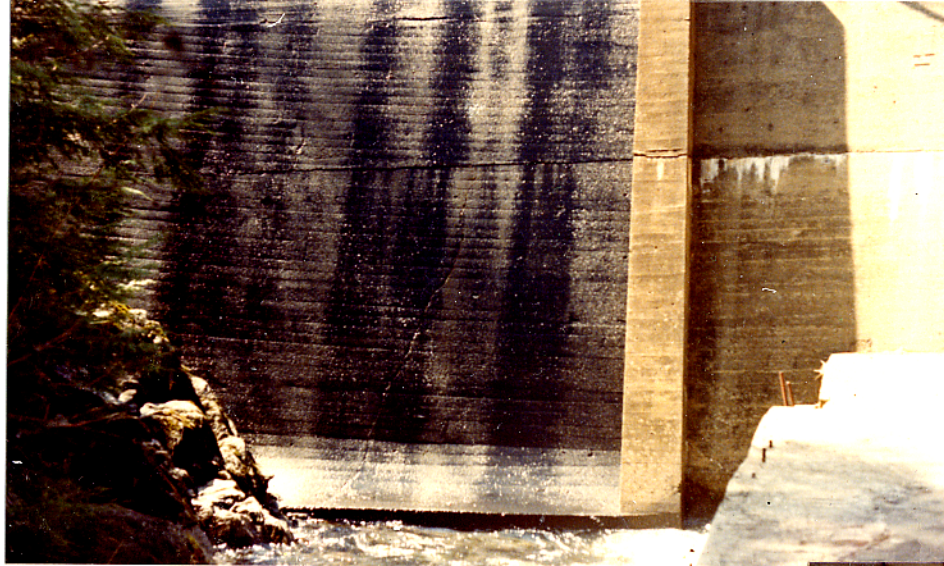
PHOTO NO. 12 - Downstream face
of spillway.

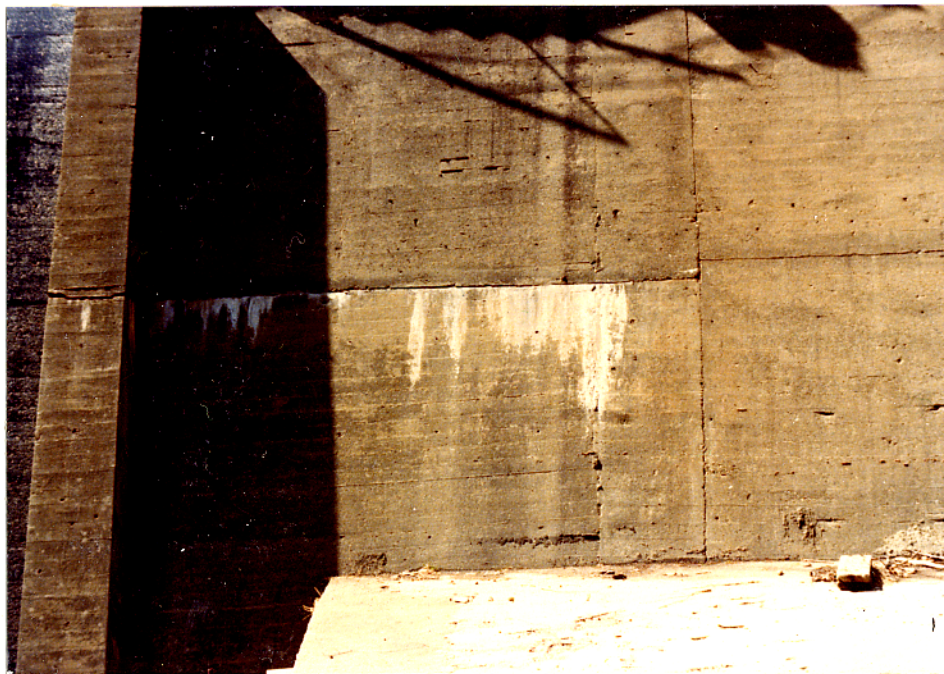
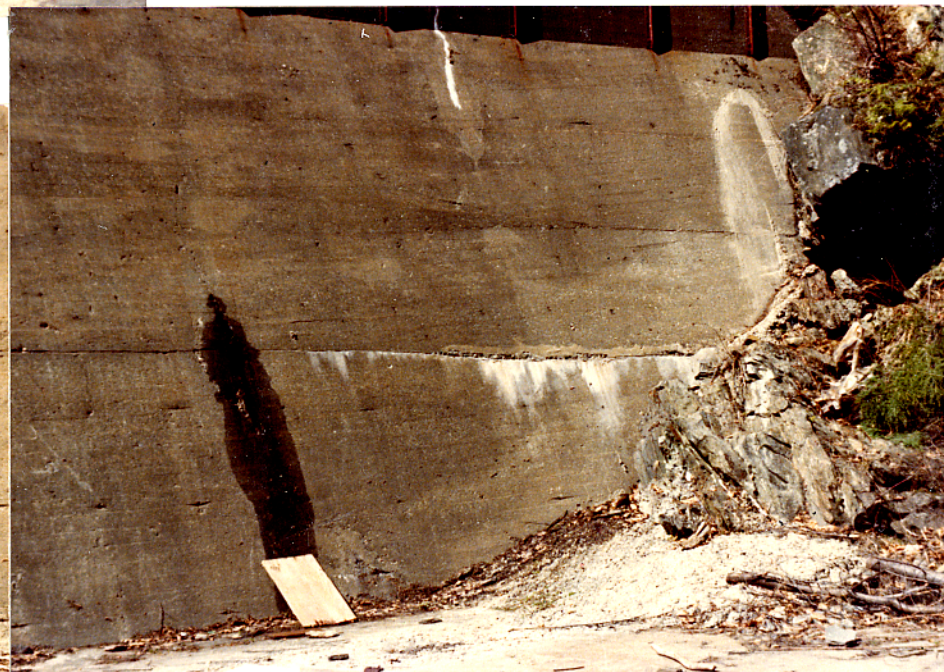
Inspection of the spillway section indicated a vertical crack running from its toe to the earlier described horizontal construction joint, photo 14. There was no observed seepage through this vertical crack.

PHOTOS NO. 13 & 14 - Downstream
face of non-overflow section. Note
seepage at vertical crack.
